Medical Devices Safety Notice

Updated Field Safety Notice

MR systems with 60cm wide bore

Quadrature Body Coil (QBC) seal adhesive failure may result in exposure of sharp edges

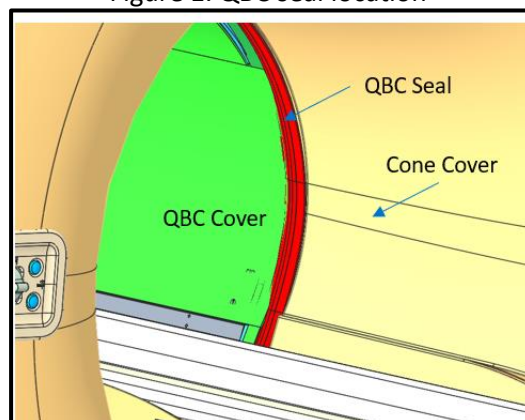
Figure 1. QBC seal location

The Quadrature Body Coil (QBC) seal adhesive may fail creating sharp edges that may come in contact with patients. The QBC seal may become loose as the patient table travels in a horizontal motion in and out of the system bore. The QBC seal (Figure 1) is a rubber seal that is glued between the cone cover and QBC cover and functions to prevent sharp edges of the QBC cover from contacting patients during an examination.

If the QBC seal becomes loose during the scanning process, the risk to the patient may include one or more of the following: skin abrasions, bruises, lacerations, hair loss/entanglement, and tissue injury.

- As part of the preparation before a patient scan:
 1. Inspect the QBC seal for separation between the cone cover and QBC cover.
 2. If QBC seal is found detached or loose, **Stop-use immediately.**

Philips will contact you to schedule a time for a Field Service Engineer (FSE) to visit your site and replace your system's QBC Seal (reference FCO78100573, FCO78100615).
